UNITED STATES ENVIRONMENTAL PROTECTION AGENCY
REGION 5
77 WEST JACKSON BOULEVARD
CHICAGO, IL 60604-3590

Subject: Order for Compliance Pursuant to 33 U.S.C. §§ 1318 and 1319(a)
Docket No. V-W-12-AO-29

Also enclosed is a copy of the report on the Concentrated Animal Feeding Operation Inspection conducted by EPA on March 22, 2012. If you have any questions concerning this matter, please contact Ben Atkinson of my staff at (312) 353-8243.

Walkthrough of the Facility

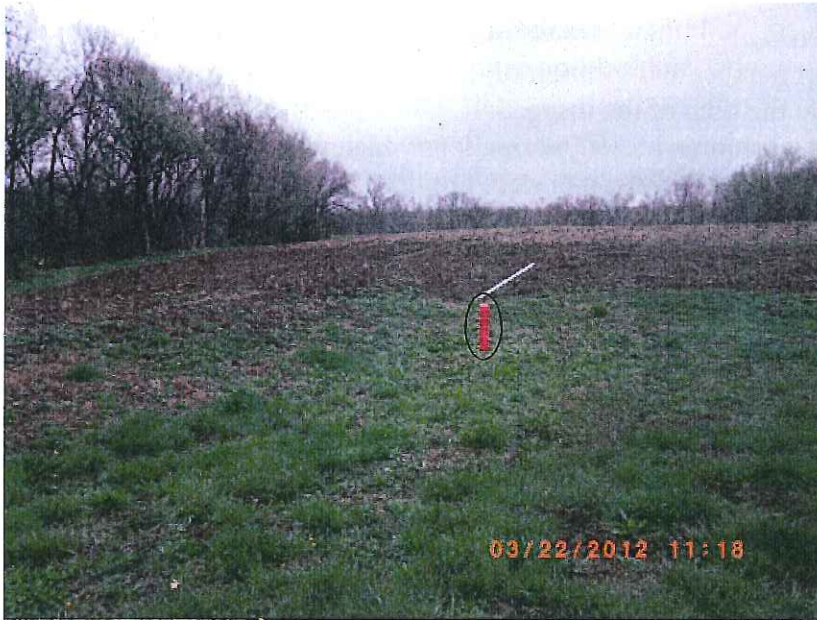
EPA began the walkthrough of the facility on southeast corner of the facility. An orange tile riser surface inlet was noted southeast of the facility's office building. The PSM representatives were unable to identify the outlet for the tile at the time of the inspection. FOIA Exemption (b) (6) of PSM later provided a map showing that this tile riser outlets to the ravine located to the east of the facility. (Attachment B)

IMGP0465: Tile riser surface inlet southeast of farrowing buildings. Facing: South
Date/Time: 03/22/12 12:18 P.M.

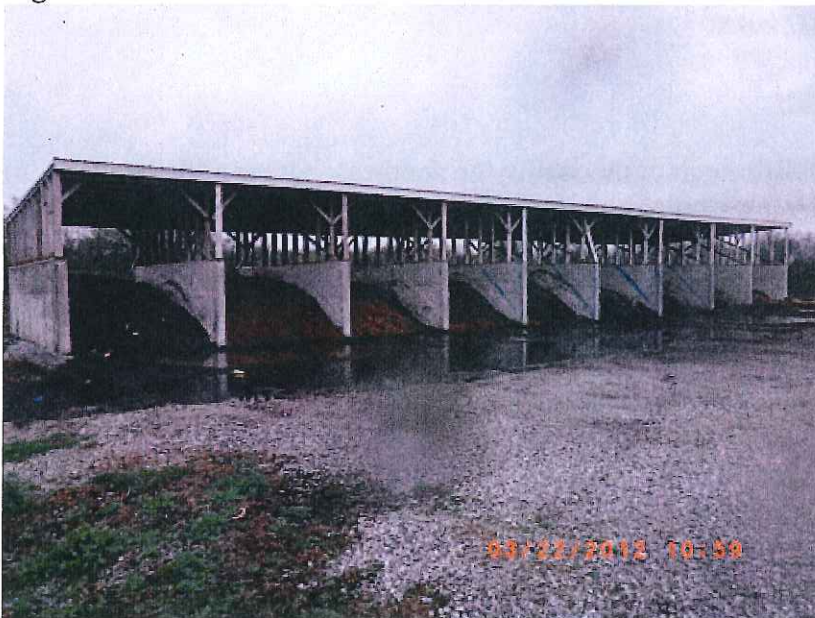
EPA walked west on the south side of the farrowing buildings. The nine bay compost facility is located south of the farrowing buildings. The compost facility was elevated and surrounded by a gravel berm. A dark leachate appeared to seep from the base of the gravel berm in several locations. The vegetation surrounding the seeping leachate appeared dead. The leachate flow pathway disappeared into the surrounding vegetation.

IMGP0454: Mortality compost facility south of farrowing buildings.
Facing: Southwest Date/Time: 03/22/12 11:59 A.M.

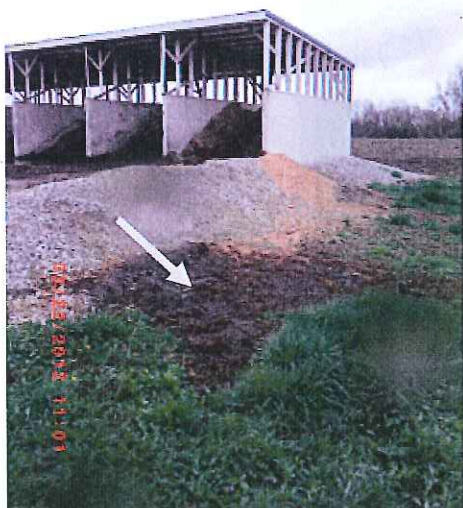
IMGP0456: Mortality compost facility south of farrowing buildings. Seeping leachate.
Facing: Southeast Date/Time: 03/22/12 12:01 P.M.

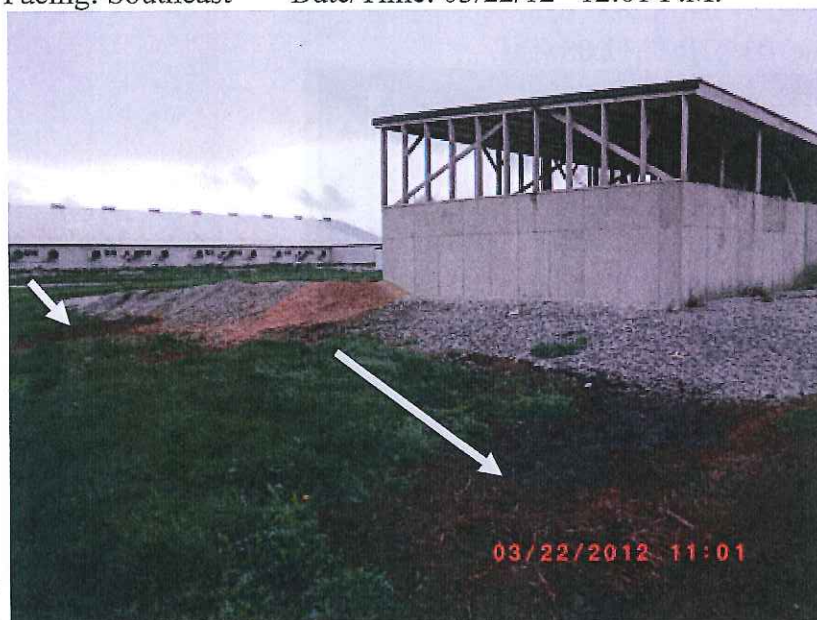
IMGP0457: Mortality compost facility south of farrowing buildings. Seeping leachate.
Facing: Northeast Date/Time: 03/22/12 12:01 P.M.

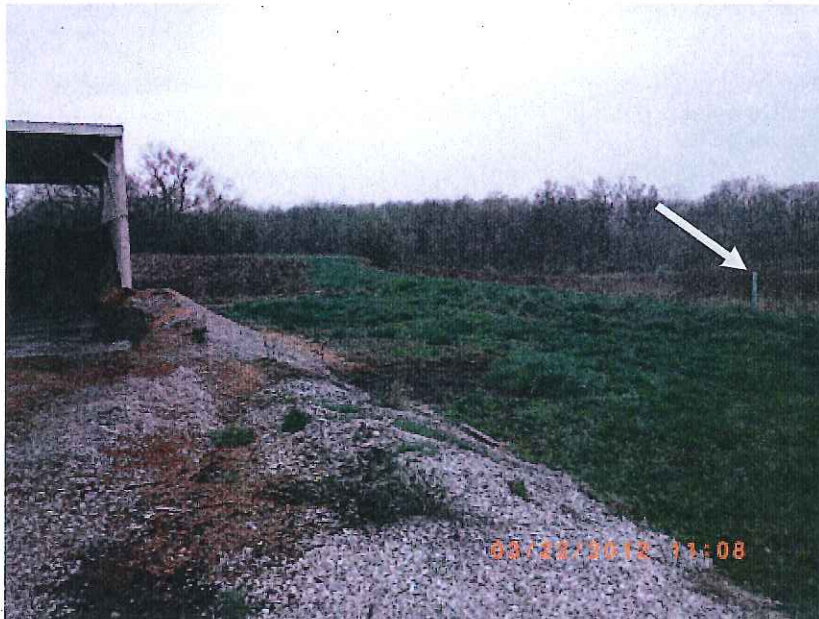
EPA noted a vertical black corrugated pipe nearly flush with the ground surface adjacent to a blue pipe protruding from the ground west of the mortality composting facility. At the time of the inspection, a whiteish soapy looking liquid was flowing into the vertical black corrugated pipe through an inlet and out of the black pipe through an outlet set lower in the pipe. At the time of the inspection, the PSM representatives were unable identify the source of the incoming liquid or the location of the final outlet of the pipe. It was determined that samples of the liquid would be taken upon the conclusion of the walkthrough.

IMGP0462: Blue pipe west of mortality facility adjacent to vertical black corrugated pipe.

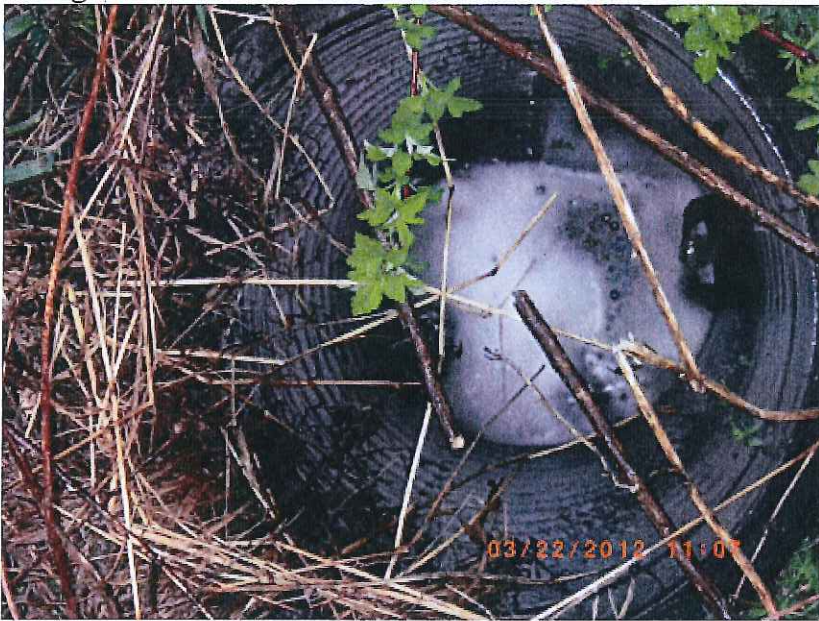
IMGP0460: Vertical black corrugated pipe with whitish soapy looking liquid.

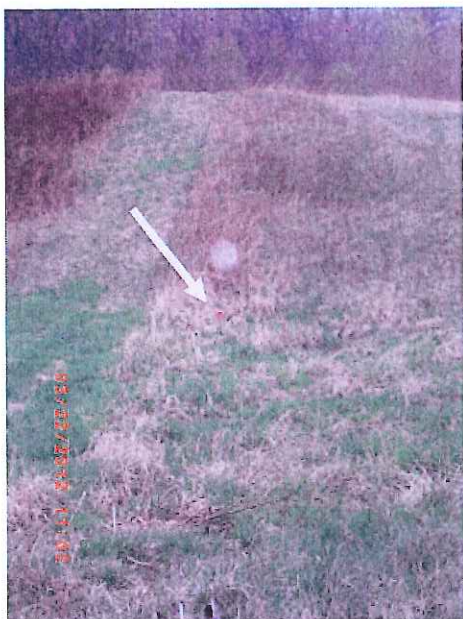
An orange tile riser surface inlet was noted in a depression west of the mortality composting facility, south of the farrowing buildings. At the time of the inspection, the PSM employees were unable to identify the location of the tile connected to the riser or the location of the outlet.

IMGP0458: Tile riser surface inlet west of mortality compost facility and south of farrowing building shown here below the arrow.
Facing: West Date/Time: 03/22/12 12:02 P.M.

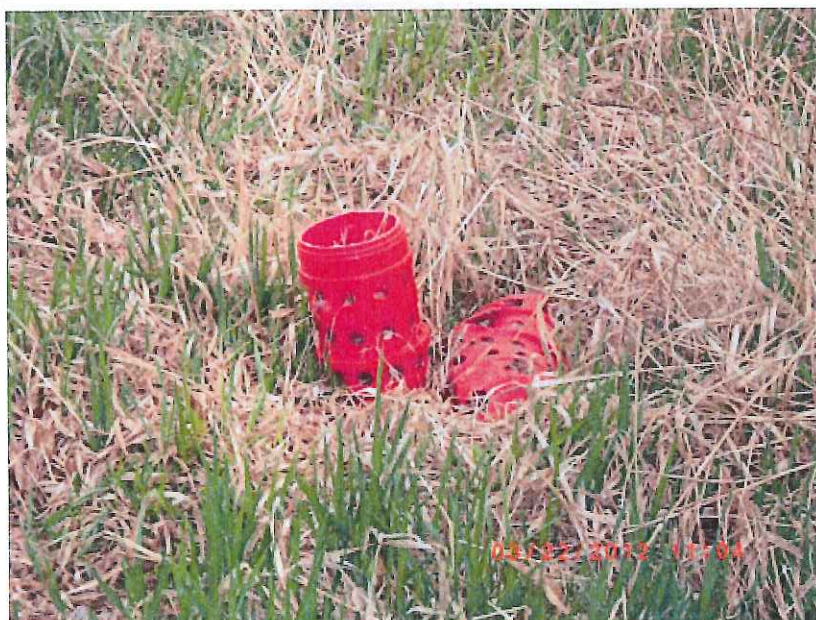
IMGP0459: Tile riser surface inlet west of mortality compost facility and south of farrowing building.
Facing: South Date/Time: 03/22/12 12:04 P.M.

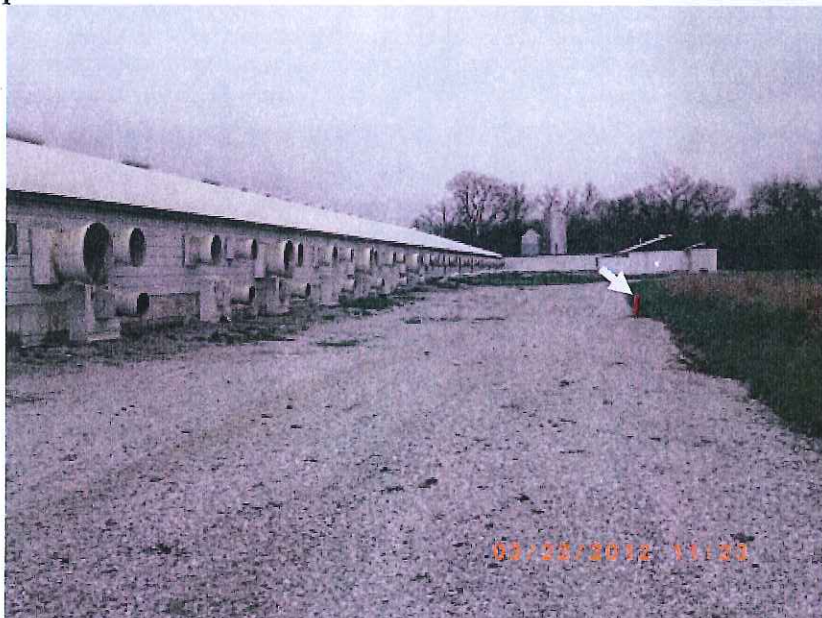
EPA continued to walk west on the southern side of the farrowing buildings. An orange tile riser surface inlet was noted on the southern edge of the gravel drive. PSM representatives stated that this riser was part of the perimeter tile. EPA walked southwest of the facility towards the unnamed tributary which flows approximately 1.1 miles

IMGP0467: Southern side of farrowing buildings with orange tile riser surface inlet.
Facing: East Date/Time: 03/22/12 12:23 P.M.

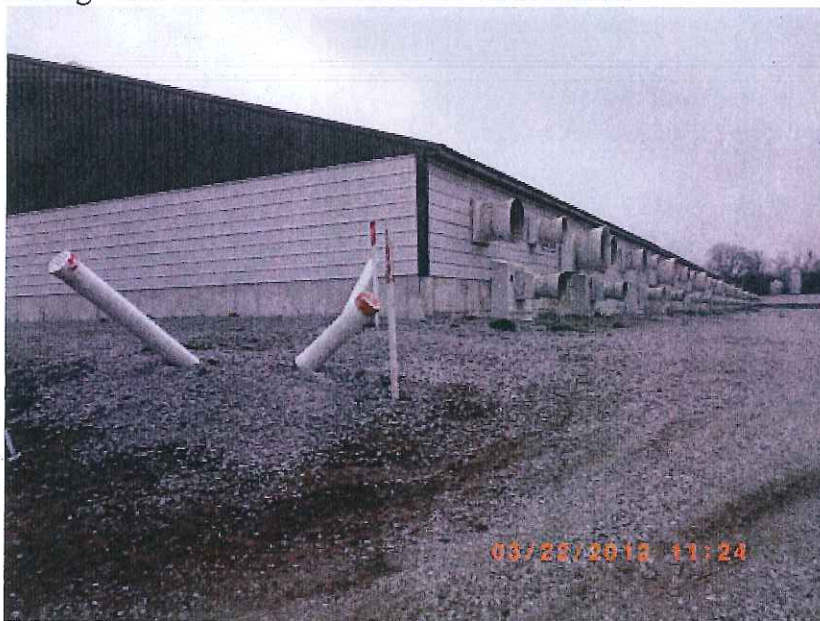
southwest to the perennial Troublesome Creek in an attempt to locate an outlet for any of the tiles. The outlet of the perimeter tiles could not be identified. Risers for the perimeter tiles were located at the southwest corner of the farrowing buildings.

IMGP0468: Southwest corner of farrowing buildings showing perimeter tile risers.
Facing: Northeast Date/Time: 03/22/12 12:24 P.M.

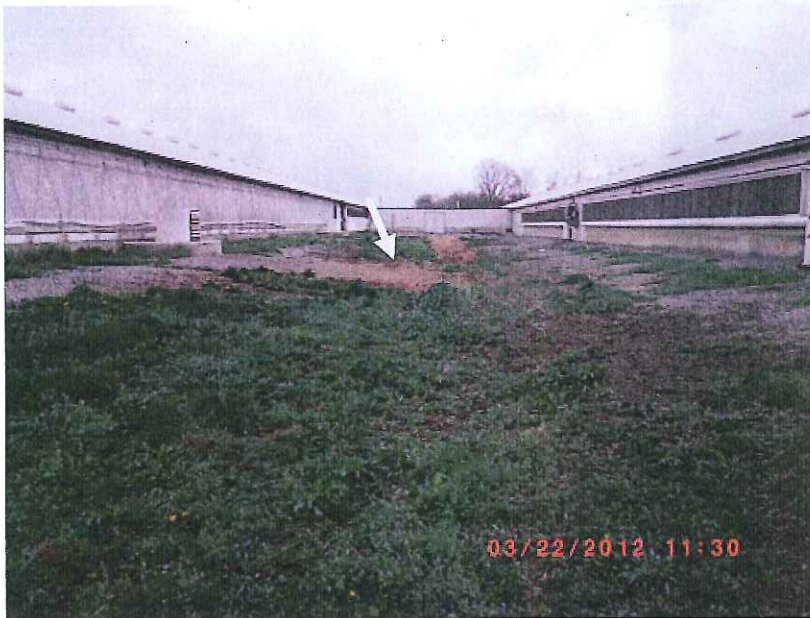
EPA walked north on the western side of the facility. EPA observed that there appeared to be areas between the farrowing buildings and the southern gestation building where the vegetation surrounding the exterior fans was dead. The storm water from between the southern gestations and farrowing buildings was directed to a tile riser surface inlet that was believed to be connected to the perimeter tile.

MGP0471: Between the farrowing buildings and the southern gestation building. Nutrient burned vegetation outside fan.

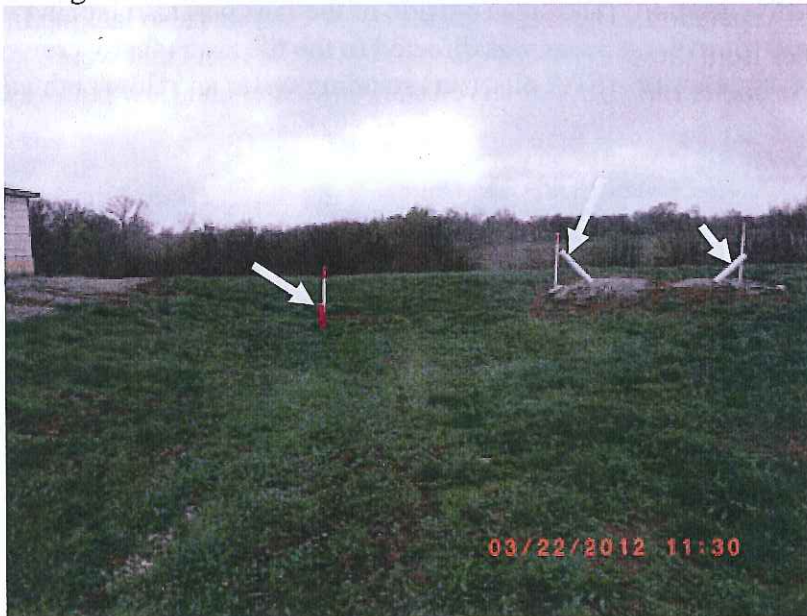
MGP0471: Between the farrowing buildings and the southern gestation building. Tile risers and surface inlet.

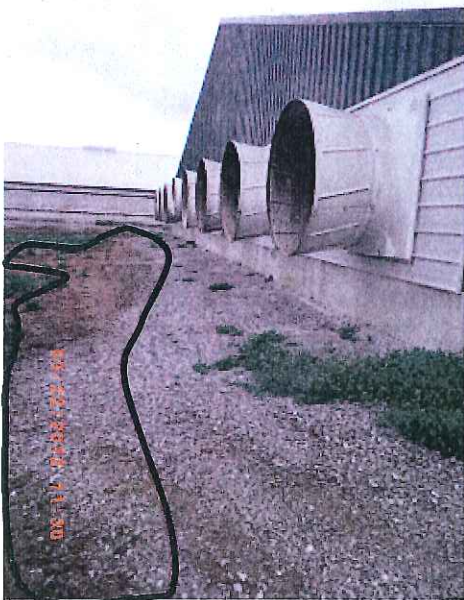
EPA noted that some areas outside of the fans on the west side of the south gestation building were only sparsely vegetated. The storm water from these areas was directed to the tile riser surface inlets which were thought to tie into the perimeter tile.

MGP0473: West of the southern gestation building. Denuded areas outside of fans.
Facing: North Date/Time: 03/22/12 12:30 P.M.

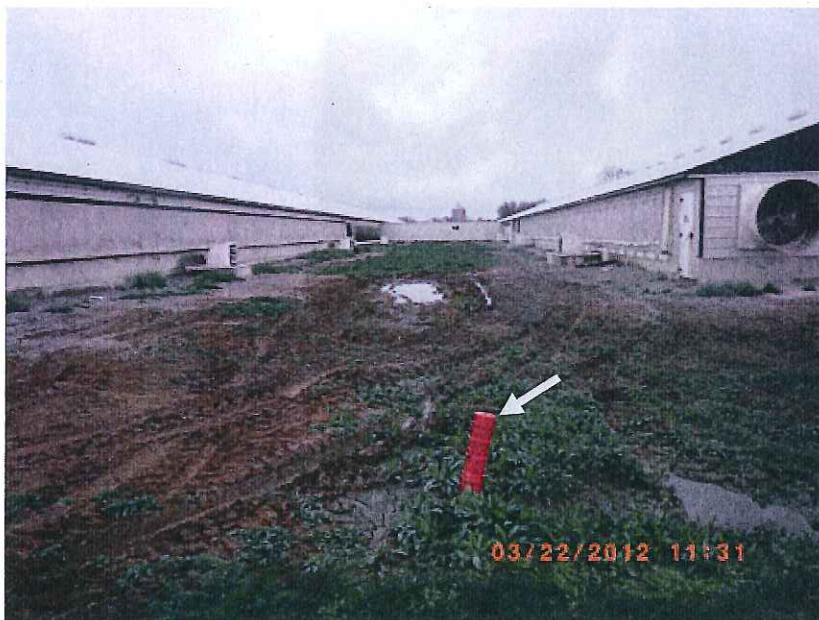
EPA observed that the area between the northern and southern gestation buildings were somewhat denuded of vegetation. The areas outside of the fans was also lacking in vegetation. The storm water from these areas was directed to the tile risers that were thought to connect to the perimeter tile. EPA observed standing water and flow pathways leading to the tile risers.

MGP0474: Between the northern and southern gestation buildings. Denuded and nutrient burned areas. Tile riser surface inlet.
Facing: East Date/Time: 03/22/12 12:31 P.M.

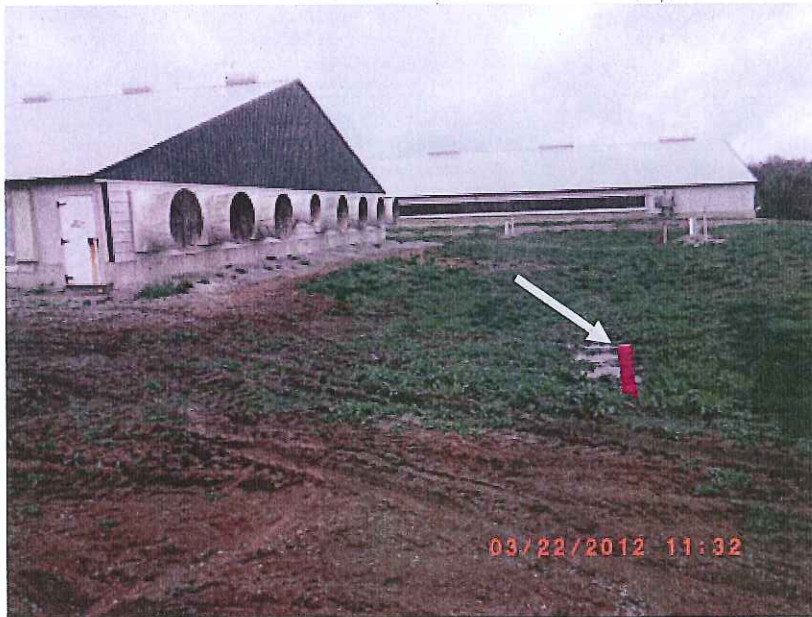
MGP0474: West of the northern gestation building. Denuded and nutrient burned areas draining to tile riser surface inlet.

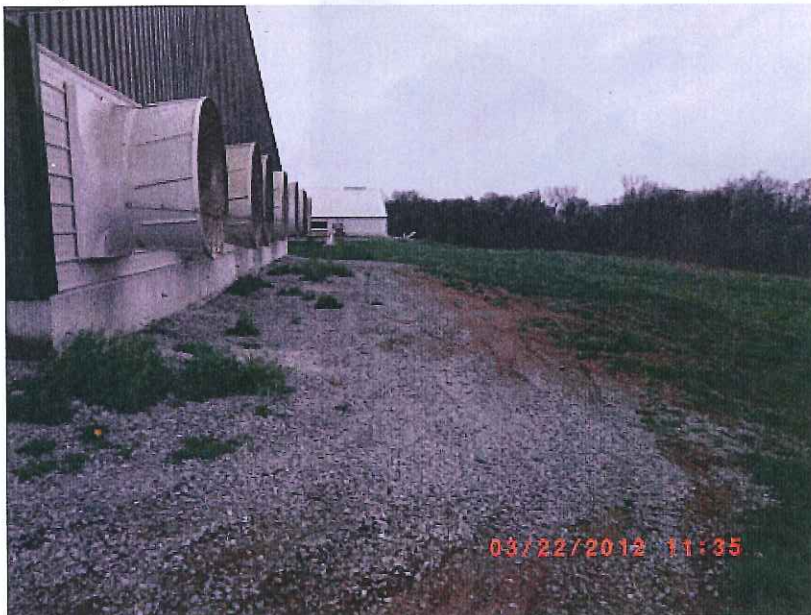
EPA walked north and observed a tile riser northwest of the northern gestation building. This riser was thought to be tied to the perimeter tile. The outlet of the tile was not known. EPA walked east on the north side of the northern building.

MGP0476: Northwest of the northern gestation building.

Facing: South Date/Time: 03/22/12 12:35 P.M.

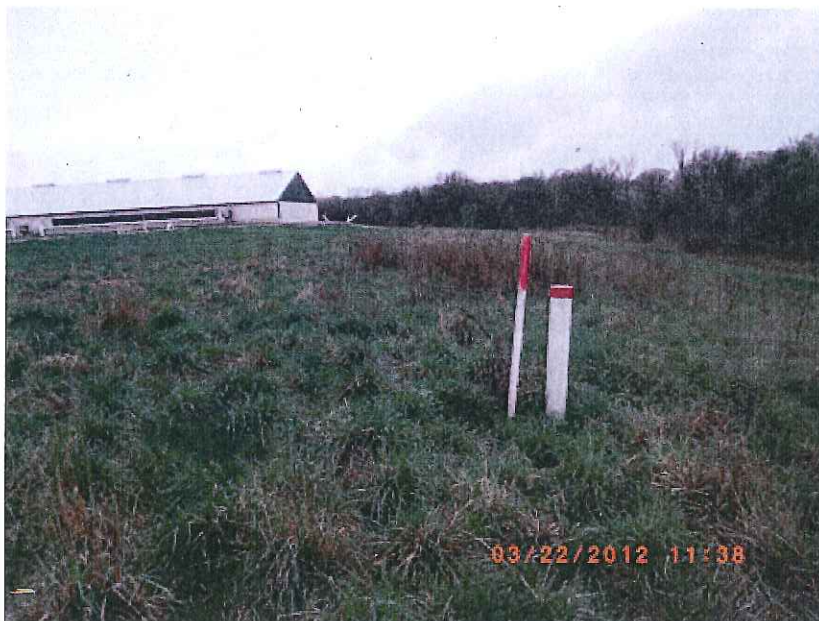
MGP0477: Tile riser northwest of the northern gestation building.
Facing: South Date/Time: 03/22/12 12:38 P.M.

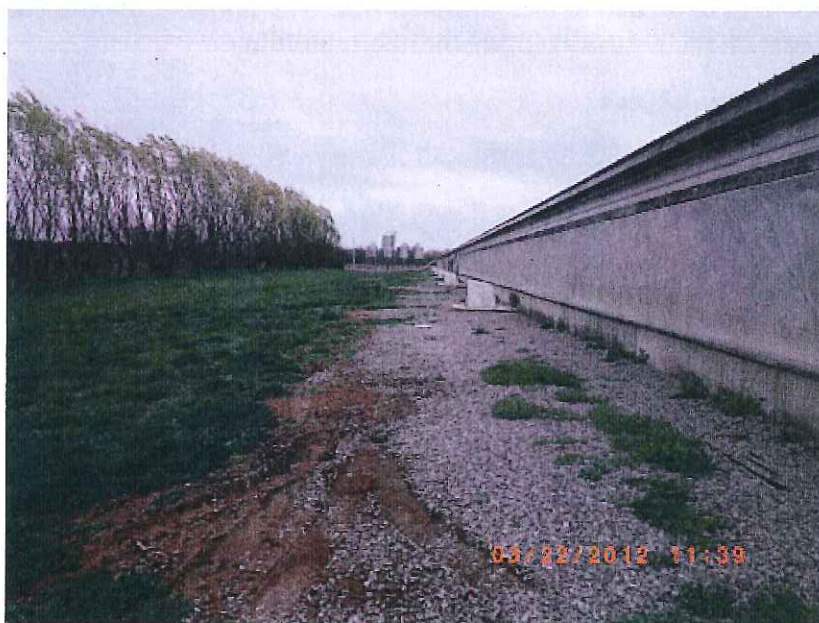
MGP0478: North of the northern gestation building.
Facing: East Date/Time: 03/22/12 12:39 P.M.

EPA walked east to the northeastern corner of the northern gestation building. EPA observed feed storage bins on concrete pads. The area around the bins was clean and free of spilled feed. EPA also observed a tile riser surface inlet north of the feed

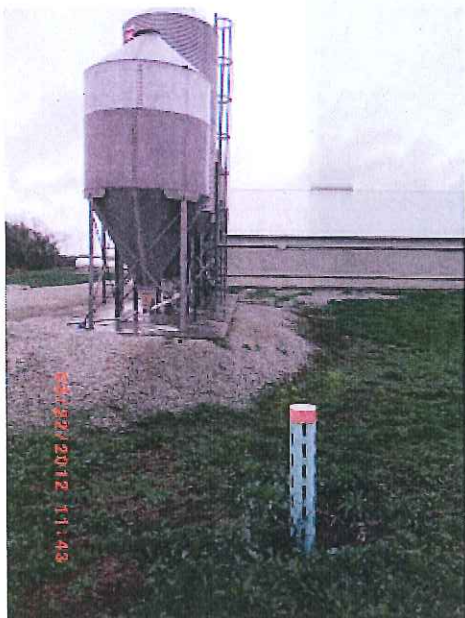
bins. The PSM representatives were unable to identify what the tile drained or where it outlets.

IMGP00479: Northeast of northern gestation building. Feed bins and tile riser surface inlet.

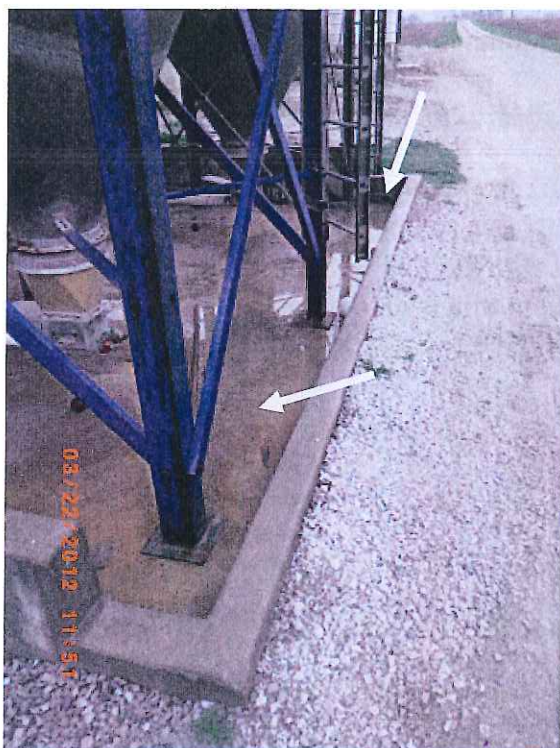
EPA walked south on the east side of the facility to a second set of feed bins. These feed bins were located between the northern and southern gestation buildings. They were located on a recessed concrete pad with drain pipe to remove precipitation. EPA observed spilled feed on the concrete pad mixing with the precipitation. This process waste water was flowing into the drain pipe. The outlet of this pipe was not able to be identified.

MGP0478: Feed bins on recessed concrete pad northeast of southern gestation building.
Drain at upper right. Spilled feed under bins.
Facing: North Date/Time: 03/22/12 12:51 P.M.

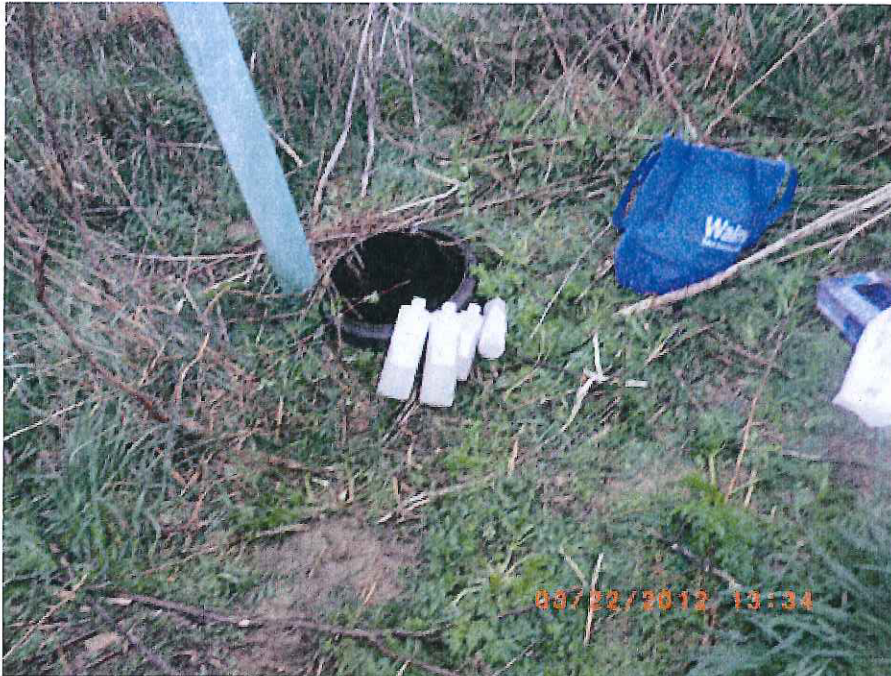
EPA informed the PSM representatives that they would be taking samples from the vertical black pipe west of the mortality compost facility and from the water next to the tile riser surface inlet between the northern and southern gestation buildings. EPA collected those samples and provided split samples to the PSM representatives. EPA walked back to the Pinnacle entrance to complete the records review. EPA reviewed the records that were kept onsite and available. It was determined that there were records kept by PSM at their Carthage office that would need to be collected. EPA performed a closing conference with **FOIA Exemption (b) (6)** EPA removed the disposable boots and disposed of them in a waste container at the Pinnacle Genetics entrance.

IMGP0348: Split samples taken at black pipe west of mortality composting facility
Facing: West Date/Time: 03/22/12 1:34 P.M.

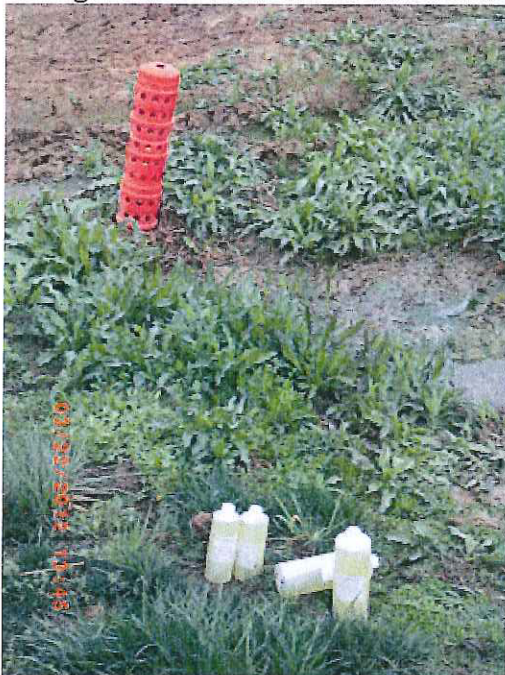
IMGP0348: Split samples taken at tile riser surface inlet west of gestation barns
Facing: East Date/Time: 03/22/12 1:45 P.M.

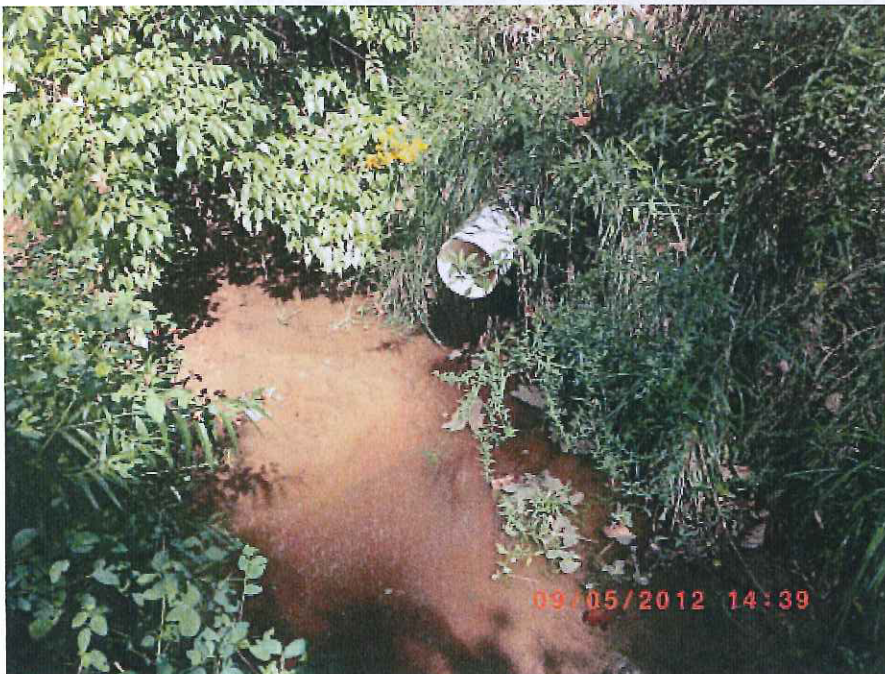
A follow up reconnaissance inspection of the outlet locations was conducted by EPA on September 5, 2012. Ben Atkinson and Don Schwer obtained permission from [FOIA Exemption (b) (6)] the owner of the land on which the outlets are located, to inspect the area along the tributary to Troublesome Creek. The outlets were identified in approximately the location shown on the map Provided by PSM. One pipe with a small discharge (dripping) was located at the western outlet location identified by PSM. Two discharging pipes, one white and one blue, were observed at the eastern outlet location.

IMGP1002: Western outlet on the unnamed tributary to Troublesome Creek
Facing: Northwest Date/Time: 09/05/12 2:39 P.M.

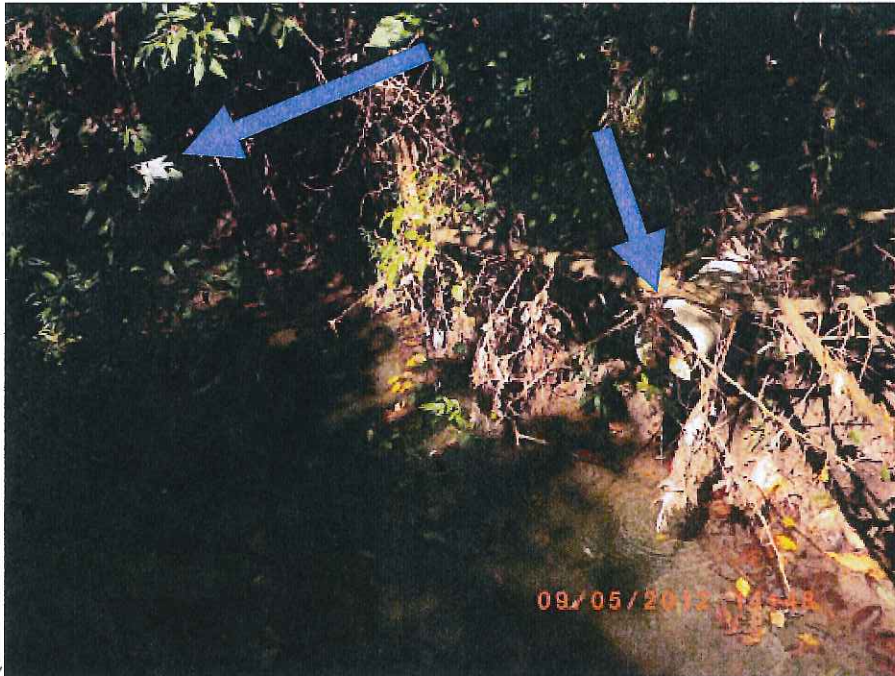
IMGP1013: Eastern outlets on the unnamed tributary to Troublesome Creek
Facing: Northwest Date/Time: 09/05/12 2:48 P.M.

A septic smell was noted around the eastern outlets. A slimy white substance was found in the tributary around the eastern outlets. Samples were taken from the discharging pipes. Sample results are not available at the time of this report.

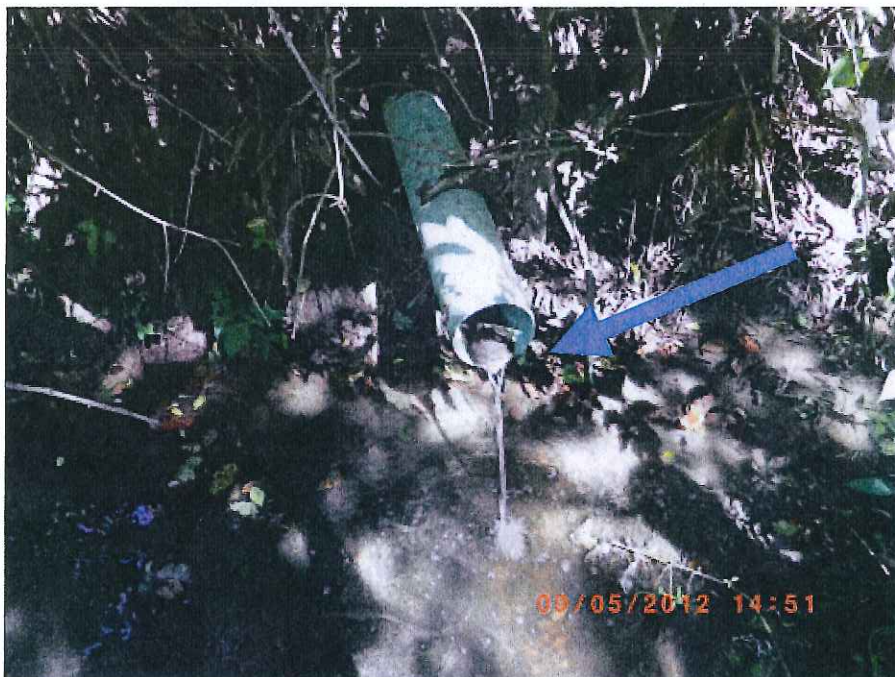
IMGP1016: Blue discharge pipe at eastern outlet on the unnamed tributary to Troublesome Creek
Facing: North Date/Time: 09/05/12 2:51 P.M.

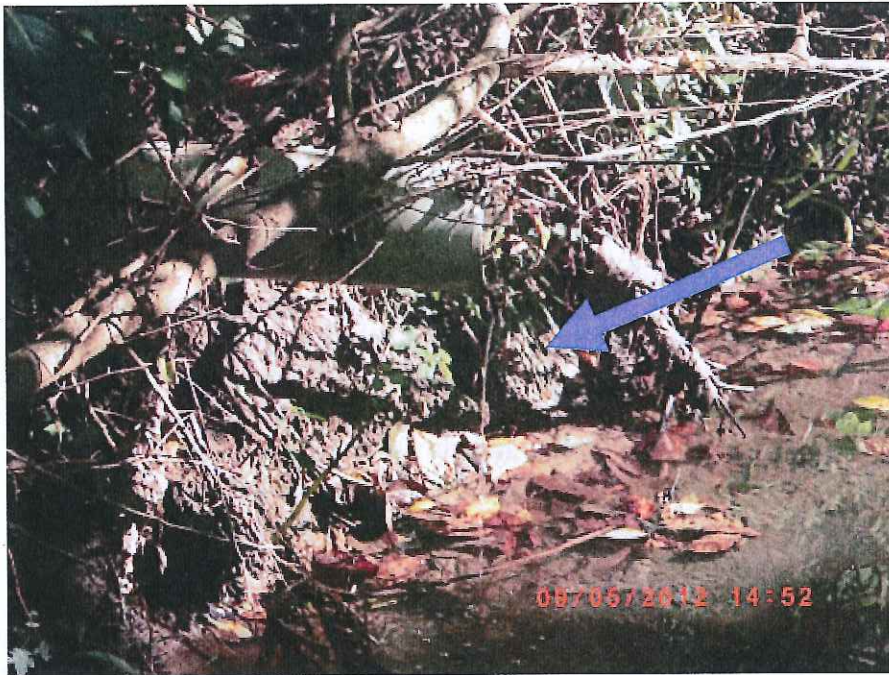
IMGP1017: White discharging pipe at eastern outlet on the unnamed tributary to Troublesome Creek
Facing: Northeast Date/Time: 09/05/12 2:52 P.M.

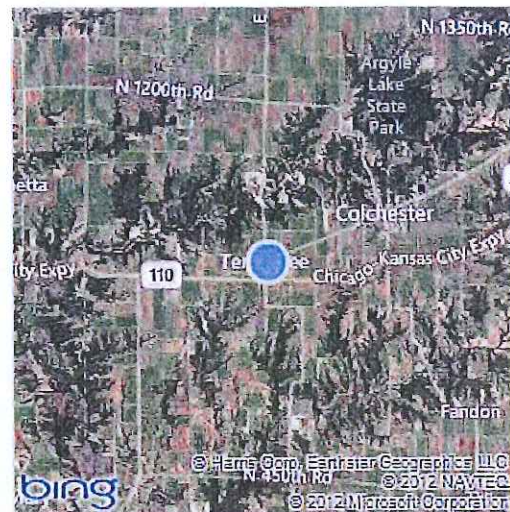
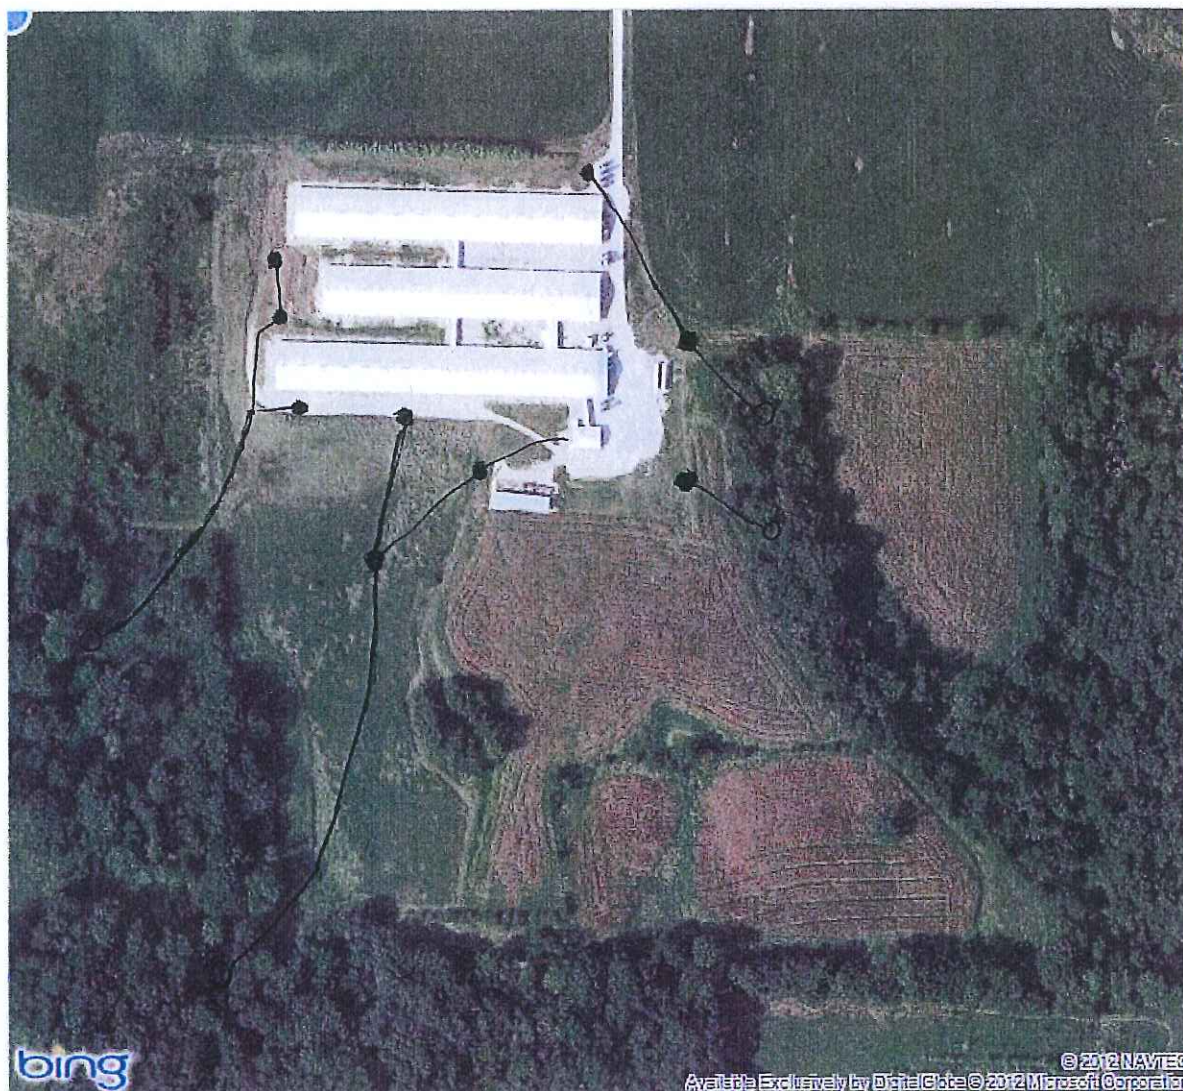
Attachment B

Additional information was provided by [FOIA Exemption (b) (6)] of PSM on June 21, 2012 regarding the locations of the outlet for the various tiles around the facility and the source of the liquid in the black pipe west of the mortality management building. The tile riser surface inlets tie into the perimeter tiles around the footings of the gestation building and outlet to the unnamed tributary of Troublesome Creek which flows south of the facility. The black pipe west of the mortality management facility is a drop box for the facility's septic. The sewage is treated by an aerobic treatment unit. This also ties into the perimeter tiles and outlets to the unnamed tributary. The location of these outlets is shown on the map provided by PSM and is included as attachment B.

● = riser
○ = outlet
— = underground line
